Technical Report REMR-CS-46  
March 1995

## **Repair and Maintenance of Masonry Structures: Case Histories**

*by Edward F. O'Neil*

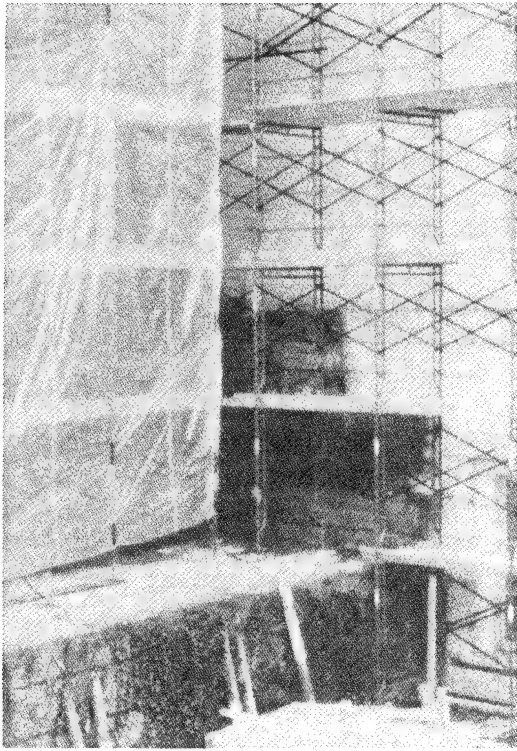
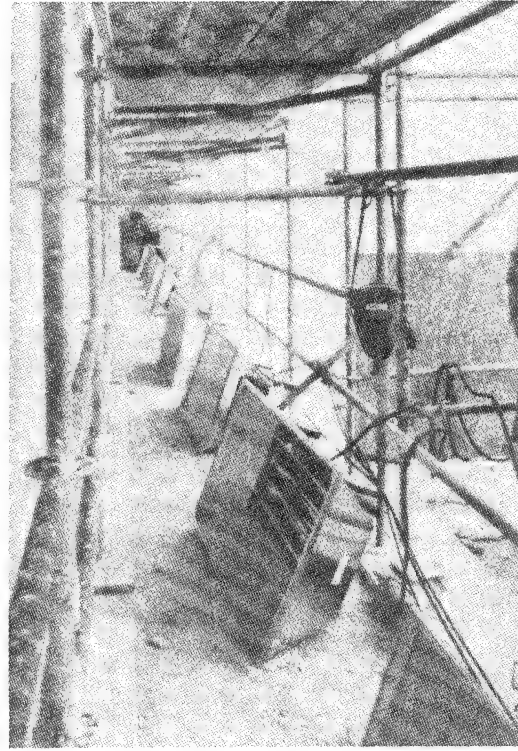
Figure 6. Enclosed scaffolding and heaters

the strengthener was applied, radiant heaters were used near the stone surface at night during the winter. The scaffolding in the area of the work was enclosed with sheets of polyethylene, and the heaters were turned on after the work day was complete, Figure 6. Surface thermometers were installed on the stone and checked each day to make sure that the temperature of the stone was above the minimum 40 °F. The heaters were then disconnected, the polyethylene removed, and the day's work begun.

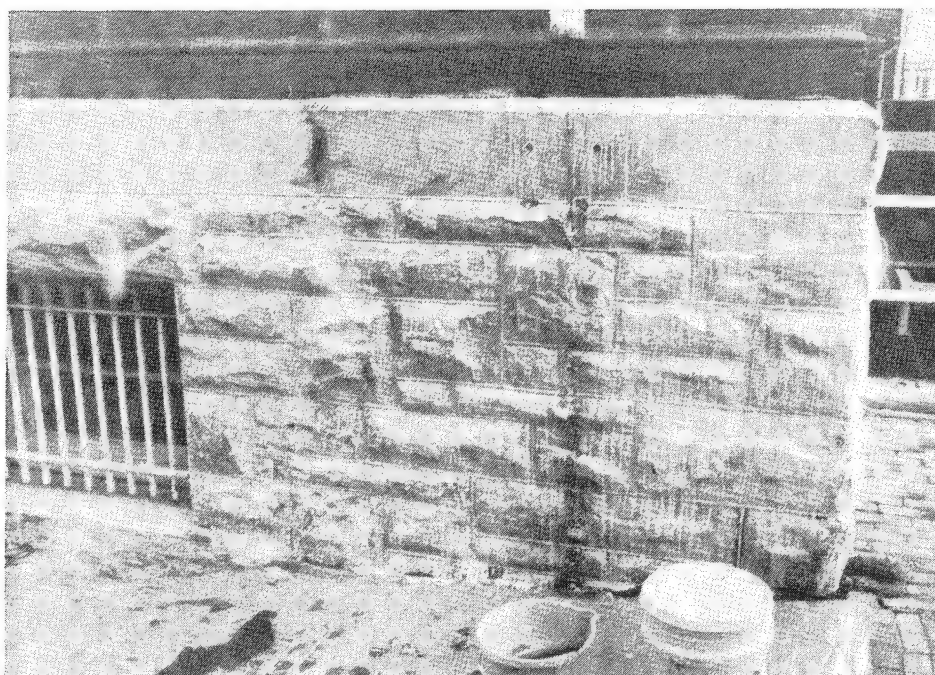
Figure 12. Limestone being cleaned with chemical spray

The chemical cleaner used to remove the surface dirt was applied by low-pressure spray equipment ( $< 50$  psi). The use of high pressures in applying the chemicals can force the chemicals into the pore structure of the material and make them difficult to remove after they have done their work. The chemicals were applied from the top of the building down. This procedure prevents chemicals and loosened dirt from coming in contact with surfaces that have already been cleaned and allows the chemicals washing down the surface to start cleaning the areas below. During the application process, care was taken to prevent the sprayed-on chemicals from being spread by wind drift. This could cause damage to areas nearby that were not intended to be cleaned such as automobiles or other buildings. The cleaning solution was allowed to remain on the wall for 3 to 5 min before being rinsed off. Figure 12 shows the brick surface as the spray is being applied.

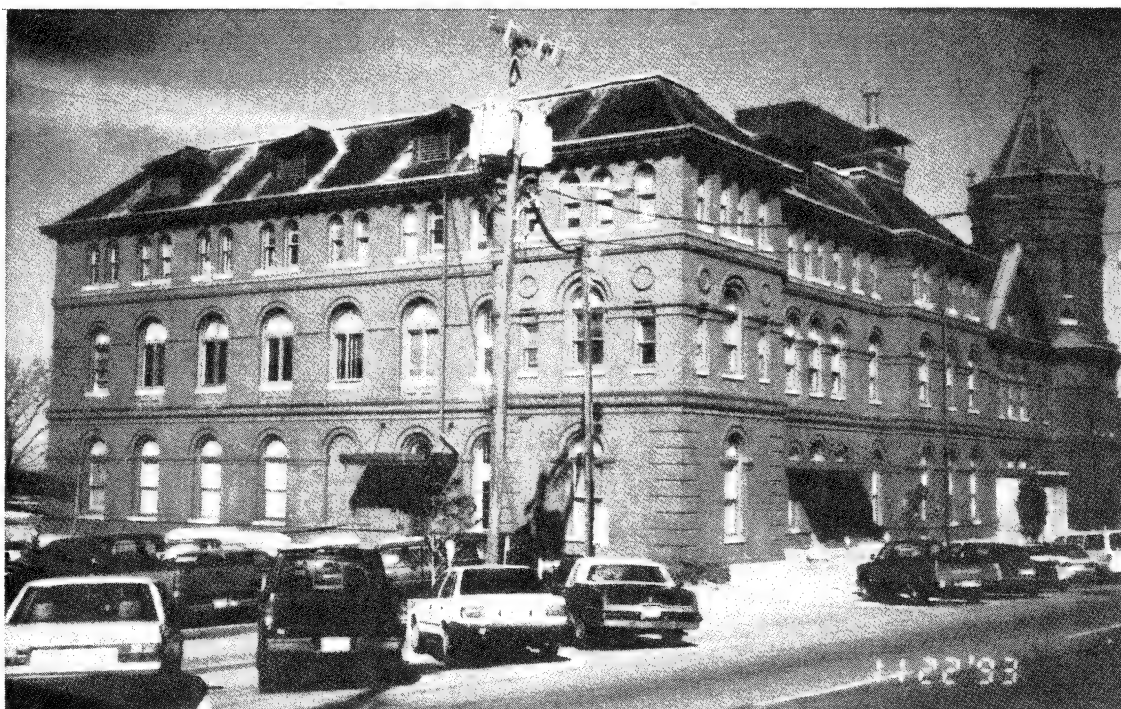
Figure 13. View of cleaned MRC Building

If the above procedure did not clean the surface the first time, it was repeated until the desired result was achieved (Figure 13).

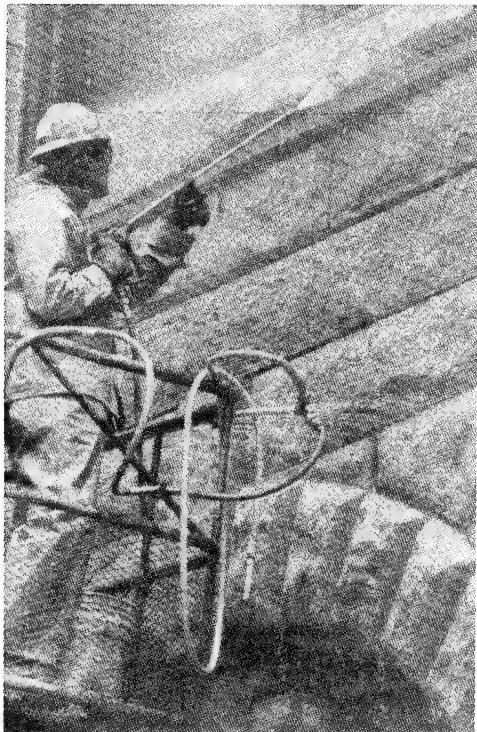
Figure 17. Limestone facade during cleaning

This procedure was used on all the limestone with very good results. Figure 17 shows some of the limestone before and after it had been cleaned. It wasn't until workers began cleaning some of the sandstone sills in Building 108 that there was any problem. The manufacturer of the chemicals used to clean the limestone recommended against using the product with sandstone because it would damage the structure of the stone. A different kind of cleaner was used to clean the sandstone parts of the buildings.

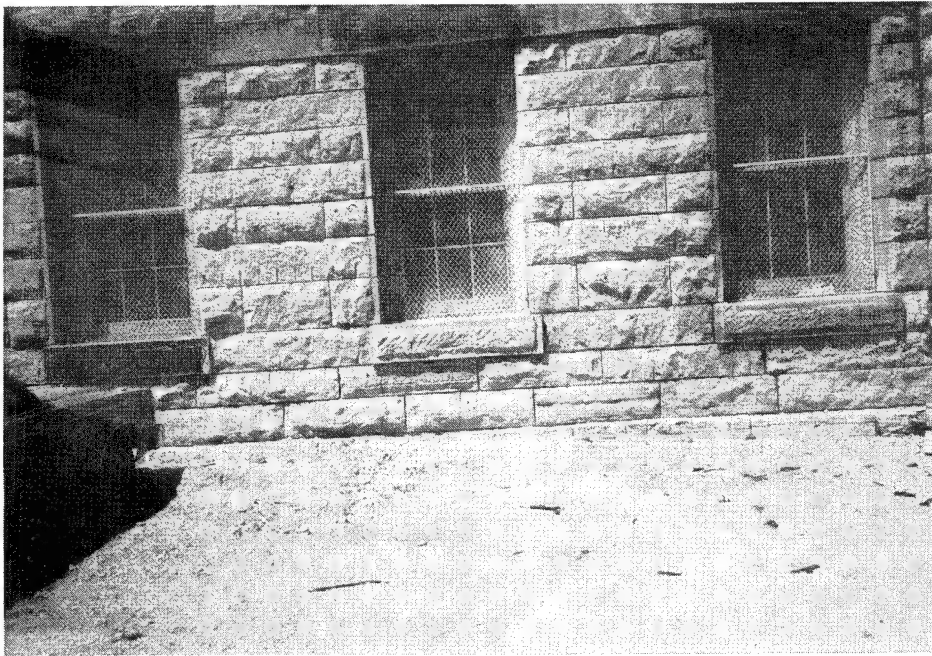
Figure 18. Sandstone sills during cleaning

Figure 18 shows the building during the cleaning process. The walls in this figure are cleaned limestone and the sills beneath the windows are the sandstone sills. The sill beneath the window on the left hasn't been cleaned in this figure while the two sills to its right have. The difference is striking.

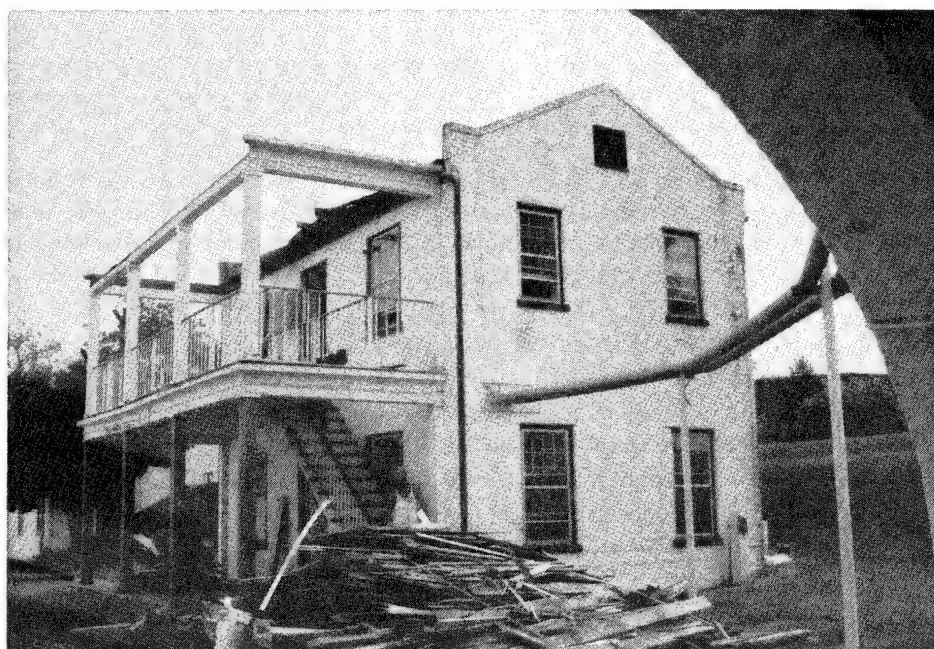
Figure 20. Storehouse showing porch during restoration

The other area of brickwork that had to be renovated was a 1- by 2-ft opening in the end wall of the storehouse that had been cut to allow steam pipes to enter the building (Figure 20.) During the restoration, the steam pipes were removed and the openings closed using the restoration brick and mortar described above.

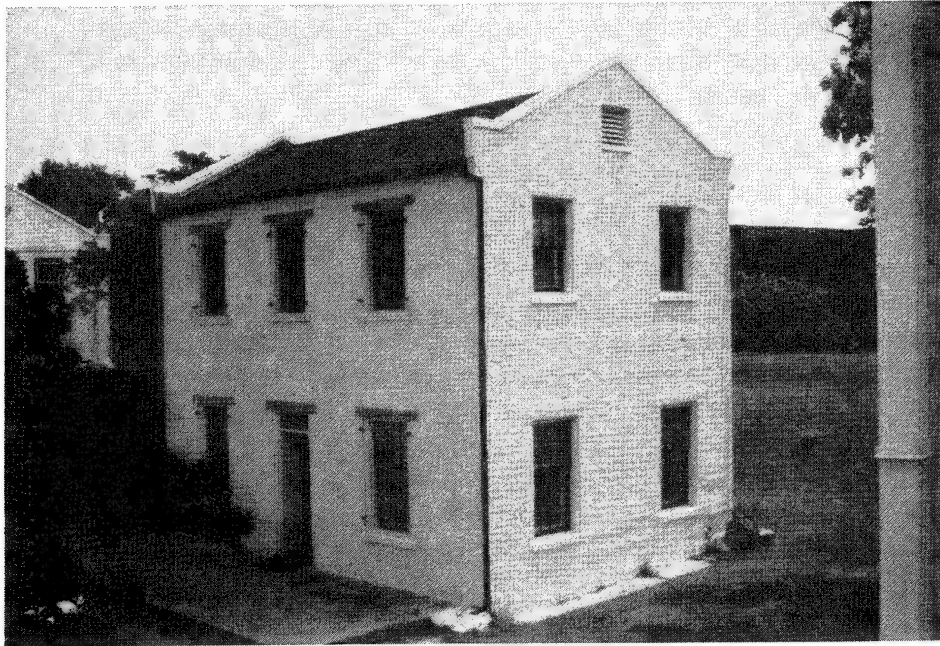
Figure 21. Completed restoration of the storehouse

The completed renovation is shown in Figure 21. All renovations are performing well as of this writing. There are no signs of deterioration of the mortar in the joints and the whitewash coat is holding up well. The restoration has returned the building to its appearance in the early 1800's.

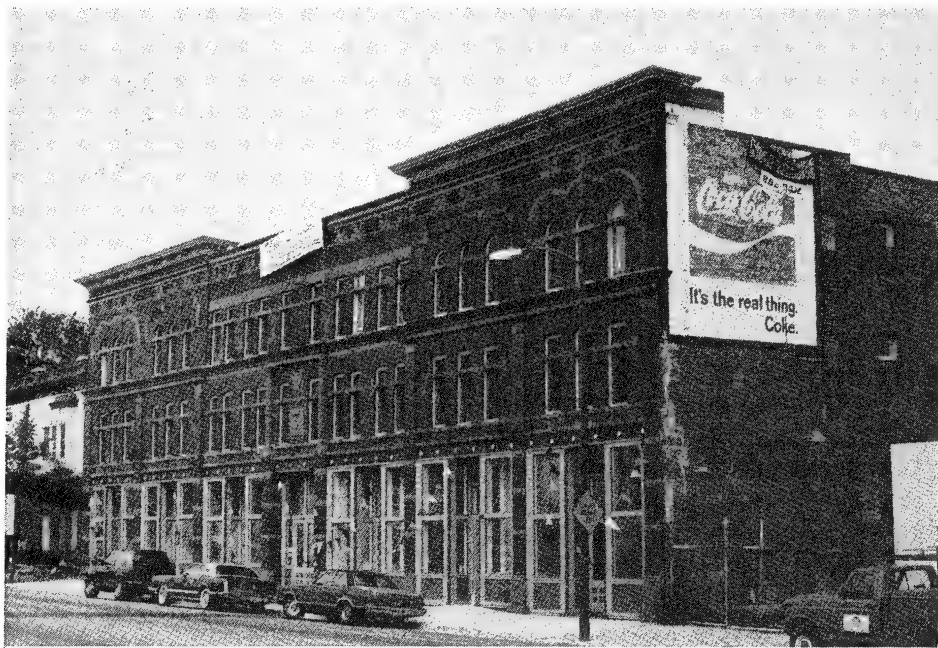
Figure 22. West facade of the Tallmadge Boyer Block

The west facade of the building, which is the front, is shown in Figure 22. This figure also shows the building in its restored condition. The brick used in this facade is hard pressed red brick. The first floor is dominated by six individual store fronts and an entrance flanked by eight brick columns. Six of these columns extend up to a subcornice between the second and third floors. The columns support steel header beams over the store fronts which in turn support the weight of the brick facade above the first level. At the first level, the brick columns are supported on sandstone pedestals which are supported on stone foundations below ground.

The south elevation is the side elevation in Figure 22 that has the soft drink sign painted on it. This elevation and those on the east and north are composed of common red brick as opposed to the hard pressed red brick of the west facade. The wall is a multiwythe wall constructed of softer brick than that of the west wall, presumably because it is not a major architectural facade. The brick was in generally good condition with some minor cracks and no pattern of structural cracking. There were some signs of deterioration of the mortar. This wall also bowed out approximately 3 in. at the center of the wall above the first-floor level. The parapet above the third floor of this wall also showed signs of deterioration due to freezing and thawing and there was some separation of the bricks and sandstone units at the intersection of the south and west walls.

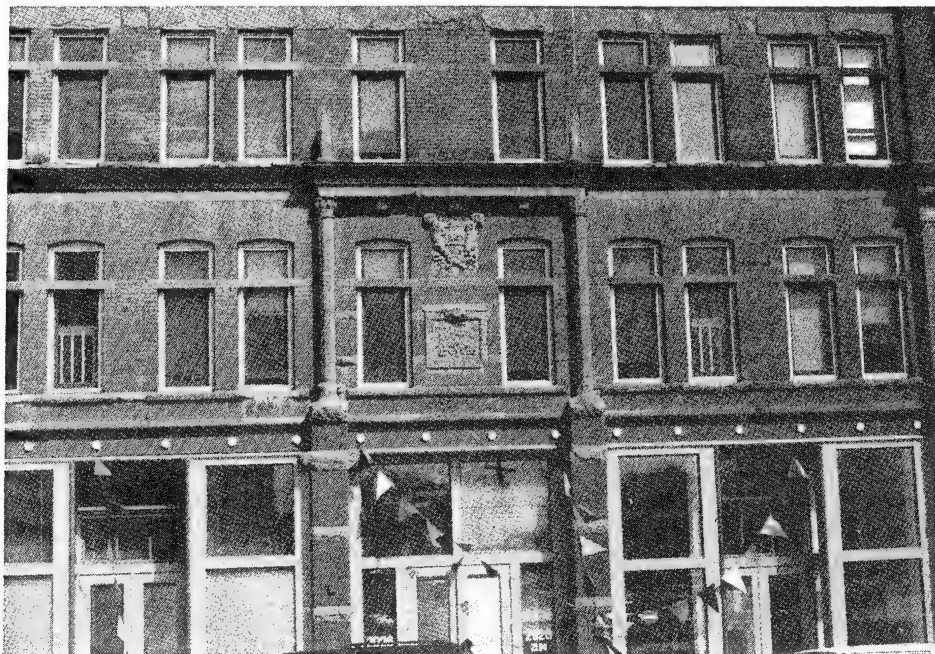
Figure 23. Elevation of the west facade showing architectural details

The second and third stories of this facade, Figure 23, are multiwythe, nonbearing brick walls. They are punctuated by 22 window openings on each floor. The brick in the facade of the second and third floors is complemented with sandstone window sills, transom sills, columns, arches, and ornamental stone work beneath the cornice topping the third floor. Figure 24 shows some of the deterioration to these stone features in a photo taken before the 1991 restoration.

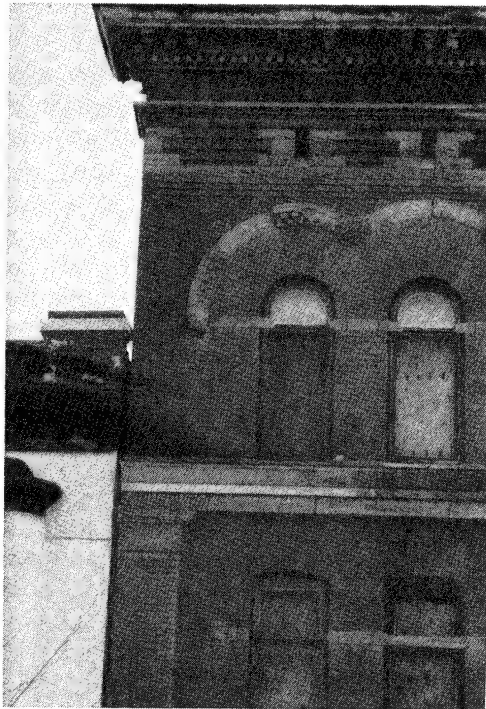
The brick columns were generally in good condition. There were some vertical cracks in the brick in some of the columns, and there was distress in the brick at the column-steel beam interconnection over the store fronts. At the second- and third-story levels, the brick appeared to be in good condition. The wall itself has bowed out approximately 3 in. at the center of the wall. The sandstone features of the wall were damaged from freezing and thawing. Observation of Figure 24 shows the sandstone transom sills above the windows on the second and third floor to have been completely weathered through. This occurs on the six windows at the north and south ends of the building. The ornamental sandstone above the third-floor window is also severely damaged. The brick arches over the second- and third-floor windows appear to be in good condition.

Figure 24. Deteriorated condition of  
windows and sills

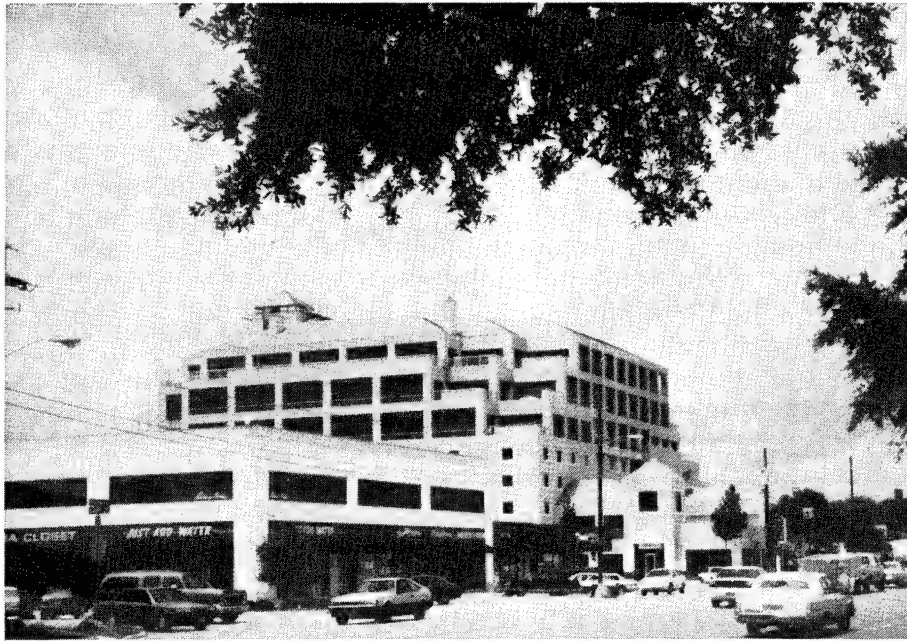
Figure 27. Site view of Berkshire Place

Within months of completion of the building, two cracking problems became evident in the cladding panels of the building. The more serious of the two conditions was a structural cracking of the panels. This problem manifested itself in the form of cracks that extended vertically through the cladding panels and aligned themselves from floor to floor to indicate a structural problem. Figures 28 and 29 show several of the cracks in the panels. As shown in the figures, some of the cracks lined up from floor to floor of the building and others originated at reentrant corners in the panels. The movement of the building frame was suspected as the cause of this cracking problem.

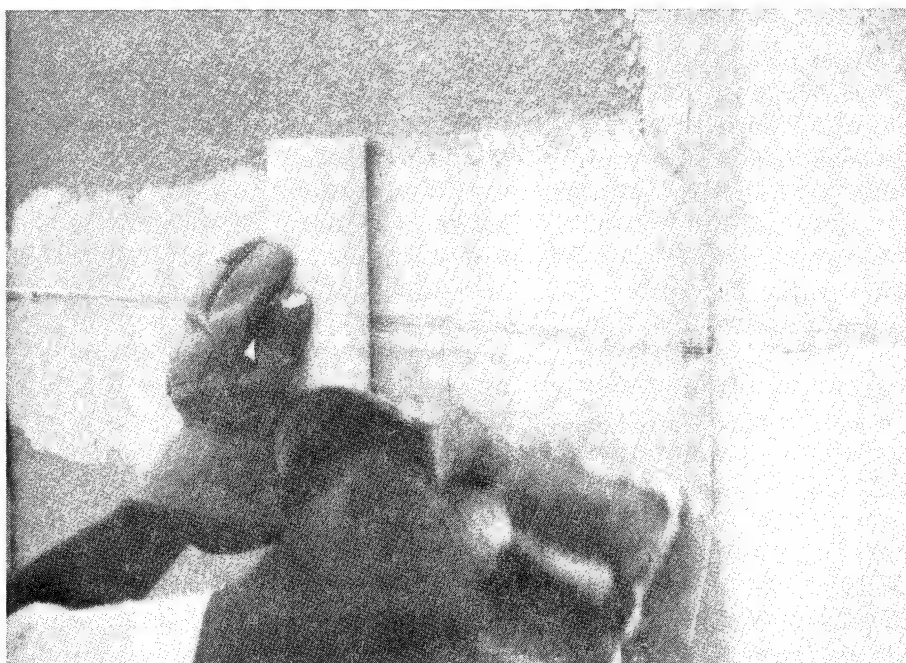
Figure 34. Trowelling of the mesh into place

The stucco-like elastomeric coating was applied in a three-step process. After all cracks in the panel were patched, the first coating was trowelled over the surface of the panel. This coating consisted of a flexible acrylic dispersion-based coat that was trowelled on in a thickness of approximately 1/32 in. Figure 33 shows a worker applying this coating to the old stucco surface of the building. This coating has a working time of approximately 30 min before it sets. Within this 30-min period, the next step must be accomplished. The second step consists of embedding a flexible polyester mesh into the still wet dispersion-based coat. The mesh is thinner than the 1/32 in. of the dispersion coat so when it is trowelled into place it will embed completely in the base coat. The openings in the mesh are approximately 1/16 by 1/16 in. The mesh is cut to the appropriate size, laid over the base coat, and then trowelled into the wet material. Figure 34 shows this mesh being trowelled into place. The base coat with mesh is then allowed to cure for 24 hr. Because these coatings are acrylic, they dissolve in water. If it is expected that the coating will be exposed to rain within the 3 hr after it is placed, it is recommended by the manufacturer that the placement be delayed until the threat of rain has passed.

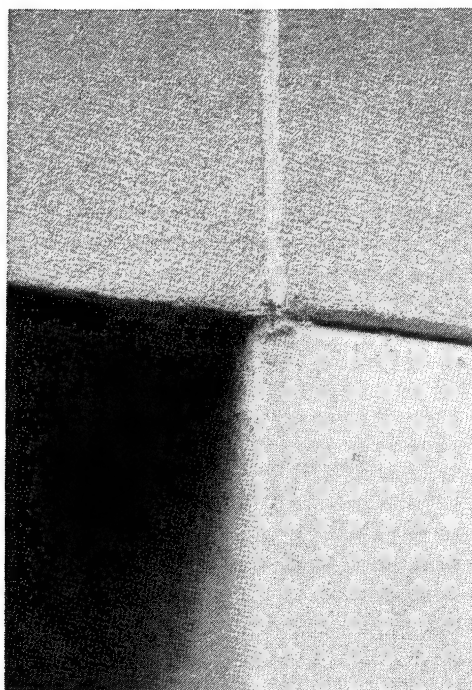
Figure 35. Contrast between base coat and finish coat

The final coating is the stucco-like coat. This coating is the same as the high-flexibility acrylic polymer coating with the addition of sand particles to the mixture. When trowelled onto the surface, this material simulates the cement stucco finish of the original building. It is also trowelled on in a 1/32-in.-thick coating. Figure 35 shows a corner detail in which the finished top coat is at the top of the figure and the base coat with the mesh is shown at the bottom.

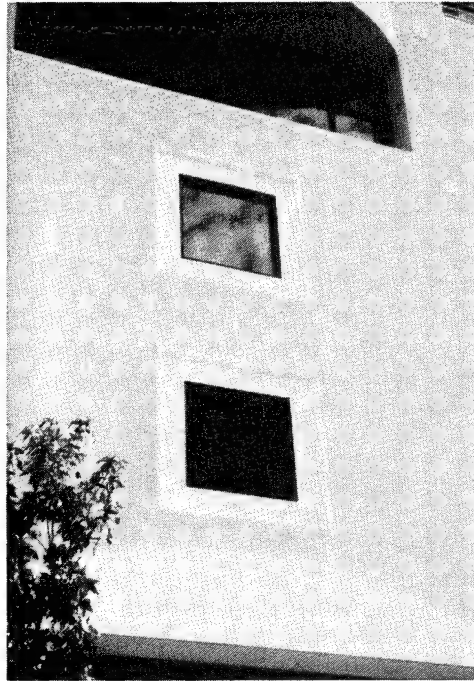
Figure 36. Repaired window frames

This procedure was very similar to the application of the base coat and mesh used on the precast panels. The surfaces of the window panels were first cleaned and filled. The flexible polyester mesh was then trowelled into the wet base coat and allowed to dry. The drying time was 1 to 3 hr to set and 24 hr before finish coat application. The acrylic coating could be applied to the base coat with a roller and in tight spaces by brush. This coating provided a highly elastic coating that would bridge the cracks as well as resist penetration of water. The application time was approximately 45 min and because this coating was applied over the base in a smooth coating, the drying time was short, from 1 to 4 hr. This provided a smooth level surface which would avoid any shadows. Figure 30 shows a cracked window frame prepared for the mesh and coating, while Figure 36 shows the final condition of the windows after repair.

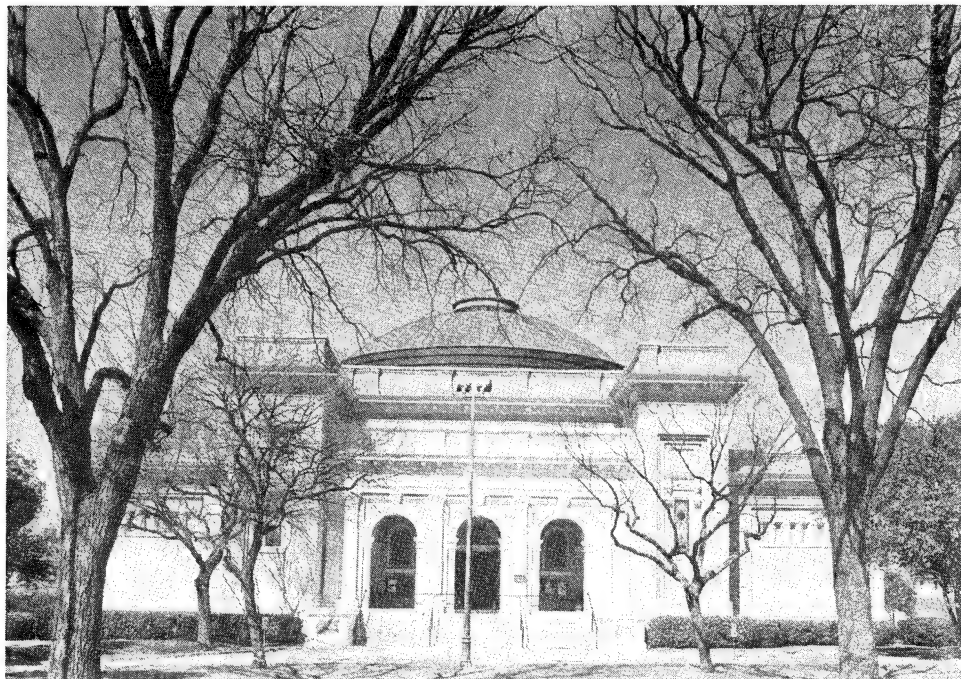
Figure 37. South facade of Gift Chapel

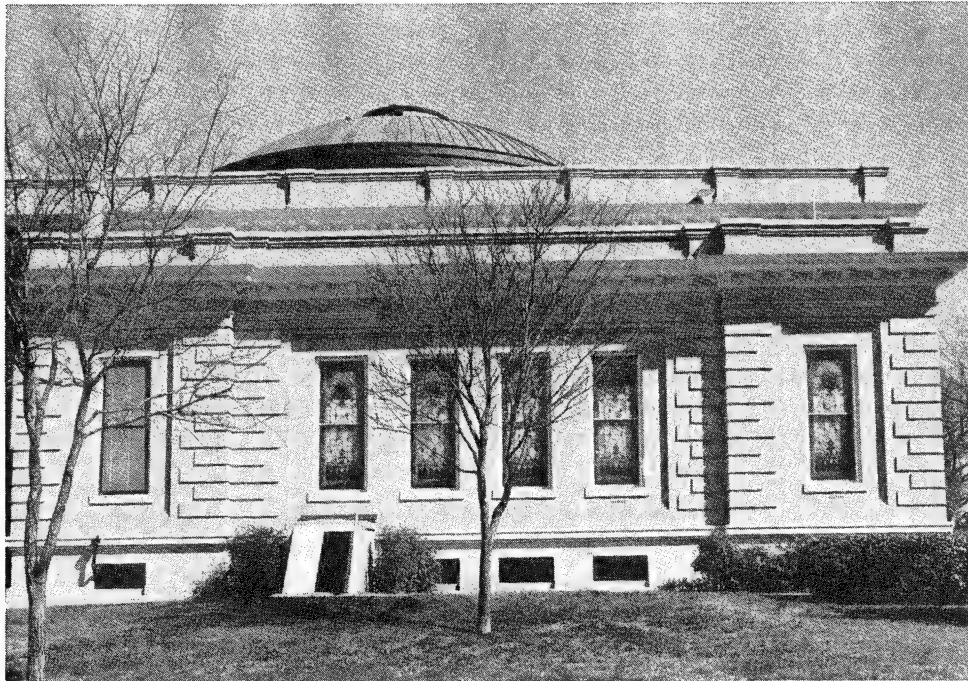
This case study is not only a restoration study, but also a structural study. The original reason for the restoration was to alleviate a problem of cracking in the east and west walls of the central chapel. Cracks in ceiling plaster over one of the wing chapels was the first reason to conduct a survey of the entire building. The building survey showed up a number of other cracks in the walls and the brickwork on the outside of the building. The major cracks were apparent in the east and west walls of the central chapel over the center of the most northern arch windows (Figure 39). The cracks were narrow at their base and became wider as they progressed up the wall. Some of the widest cracks could not be seen from within the chapel itself and had to be viewed from above the inside ceiling of the central dome. These cracks were on the order of inches wide and penetrated completely through the thickness of the wall. This led engineers to suspect that there was differential settlement of the building and that the front and back portions of the building were settling in different directions. A survey of elevations of the building was conducted and it was determined that the south face of the building had settled over 4 in. in relation to the north face.

Figure 38. Elevation of the west facade

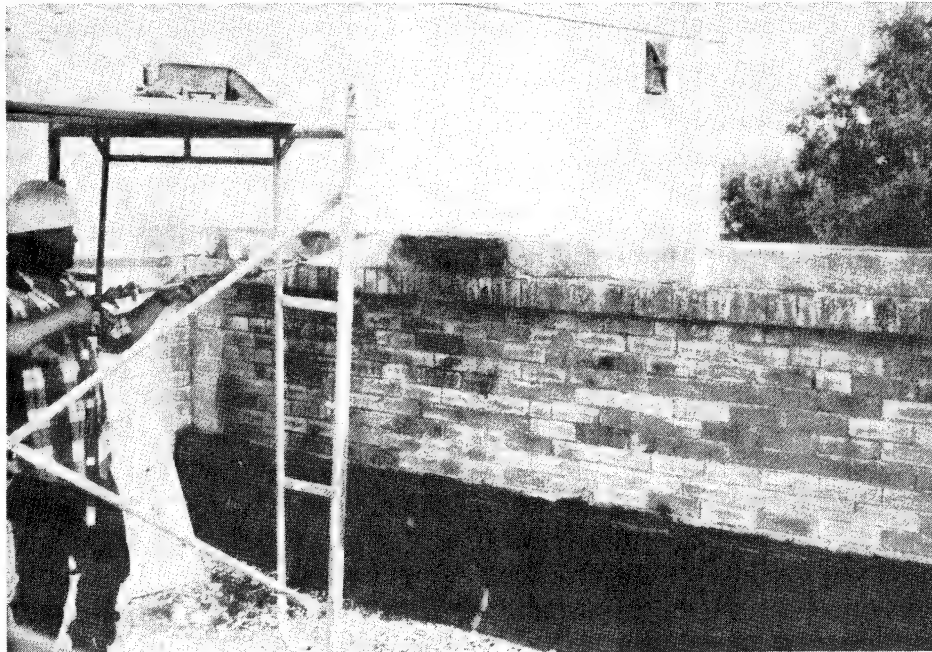
Figure 45. Medium pressure water cleaning of masonry

**Masonry cleaning.** While the masonry repair was going on, the chapel was being washed of the many years of dirt and grime it had collected. The contractor decided that the washing could be accomplished without using chemicals since the dirt on the bricks was only soil and some light coating of pollution. The decision to use no chemicals allowed him to wash before some of the repointing. He proceeded to wash with water at a medium pressure. Figure 45 shows a workman spraying the parapet walls on the roof of the east wing of the chapel. The water was sprayed on the bricks at a pressure of approximately 400 psi. This was considered strong enough to remove the grime and any loose mortar in the joints without damaging mortar that was strong. The entire chapel was washed from the top down to keep newly washed areas from being recontaminated from draining dirty water.

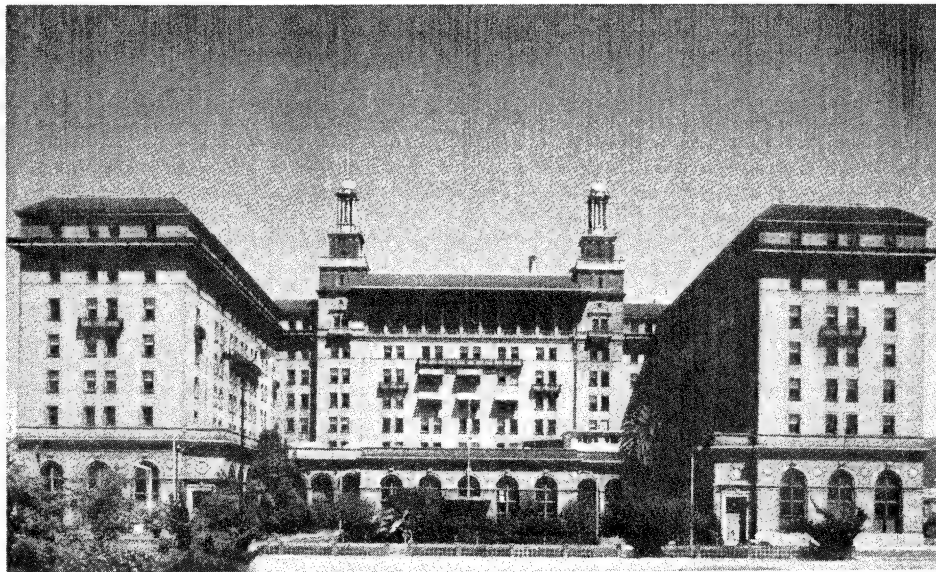
Figure 46. View of Hotel Oakland

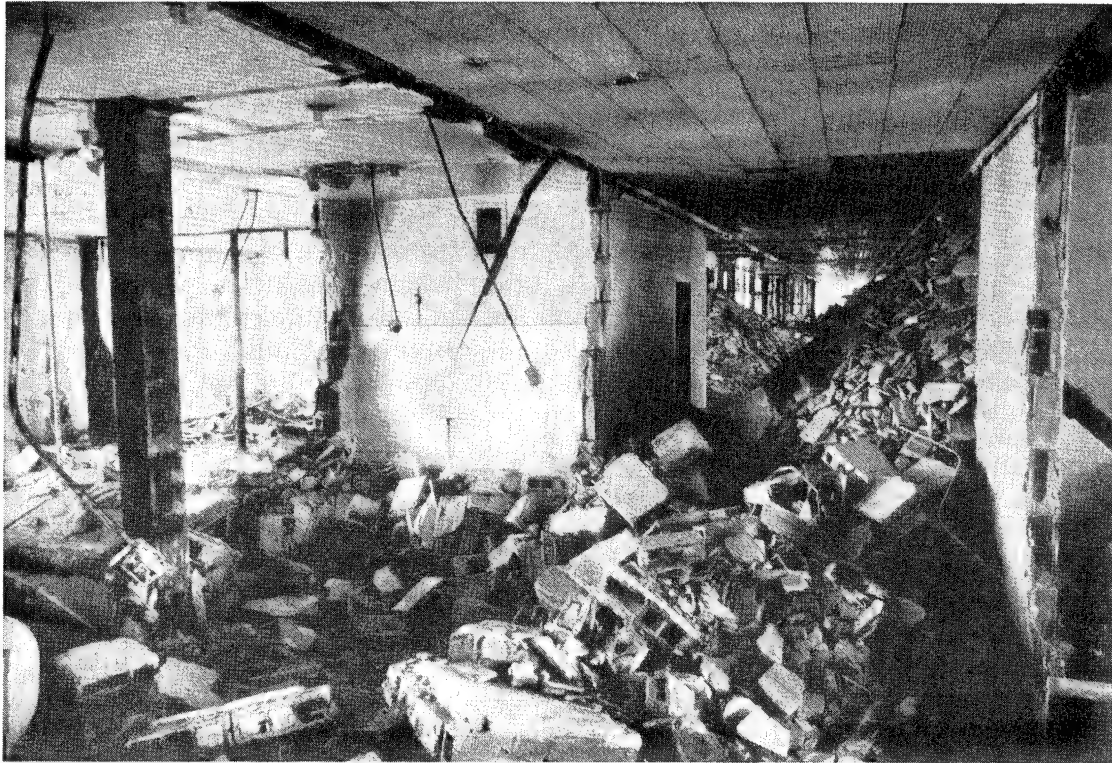
In the initial efforts to renovate the building, many schemes were tried to remodel the existing rooms and corridors for apartment use. It soon became apparent that the existing scheme of rooms would not provide the number of units necessary to financially carry the project. This, coupled with the fact that the interior walls were constructed of hollow clay tile, led to an early decision to demolish all interior walls from the underside of the roof to the basement. Exceptions to this decision were the concrete floors, the exterior walls and the historical rooms. Removal of the hollow clay tile partitions eliminated substantial earthquake hazard, since they will shatter in an

earthquake. Figure 47 shows these tiles during the 1979 renovations. This also reduced the total mass of the building thus lowering the effective earthquake inertia forces.

Figure 47. Clay tile partition rubble from 1979 renovations

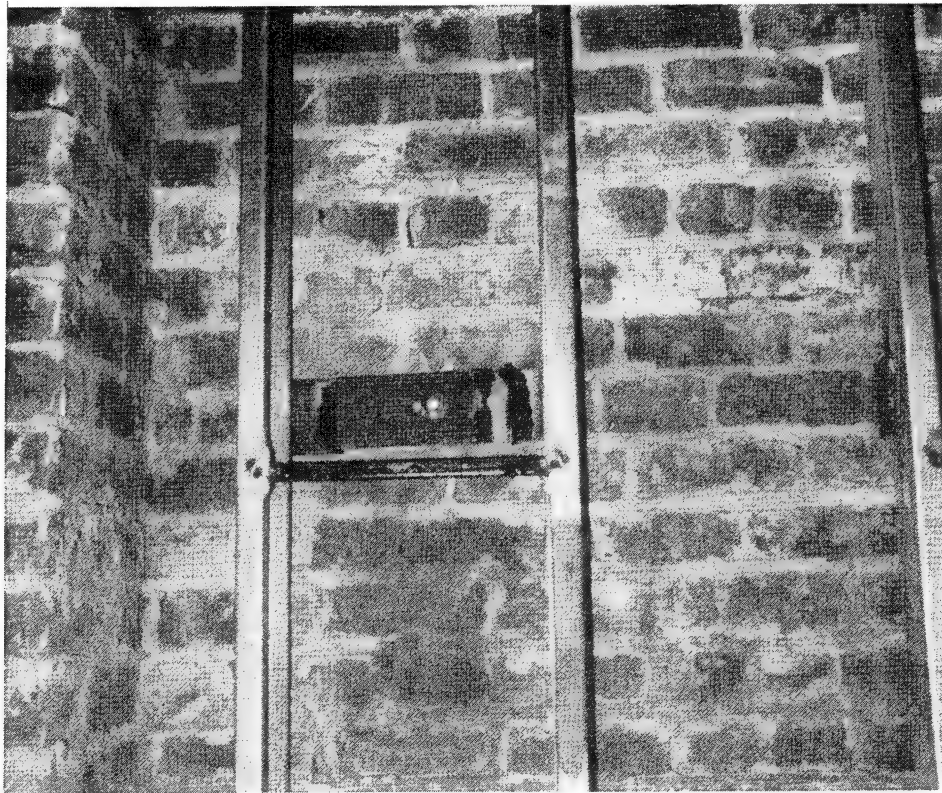
Figure 48. Overall view of structural studs and wall anchor

To effect this type of performance, the decision was made to provide a basketing system to stabilize the brick walls after cracking occurred. The system devised was incorporated into the new wall furring which was applied to the interior of the steel frames of the exterior walls. Figures 48 and 49 show some of the system details. Heavier structural studs were mixed in with the basic stud furring system. These heavy structural studs were spaced to allow wall anchors to be secured at approximately 3 ft on center in both vertical and horizontal directions. The wall anchors were 1/2-in.-diam bolts long enough to extend from the structural studs through the two interior wythes of the exterior wall and into the face brick. The bolts were inserted into the wall through holes drilled into the brick to a depth including partial penetration in the face brick. They were then anchored to the brick with polyester-resin epoxy cartridges.

Tests were conducted to determine the strength of the epoxied bolts in the brick. Prior to the actual use of this system, three anchors were epoxied into brick test panels and were loaded to failure. One failed at 7,500 lbf, and the other two at 9,000 lbf, with all failures occurring in the anchor, not in the brick or in bond between the brick and the anchor. There were 4,900 bolts used in the wall renovation, and 520 of these bolts were subjected to pullout

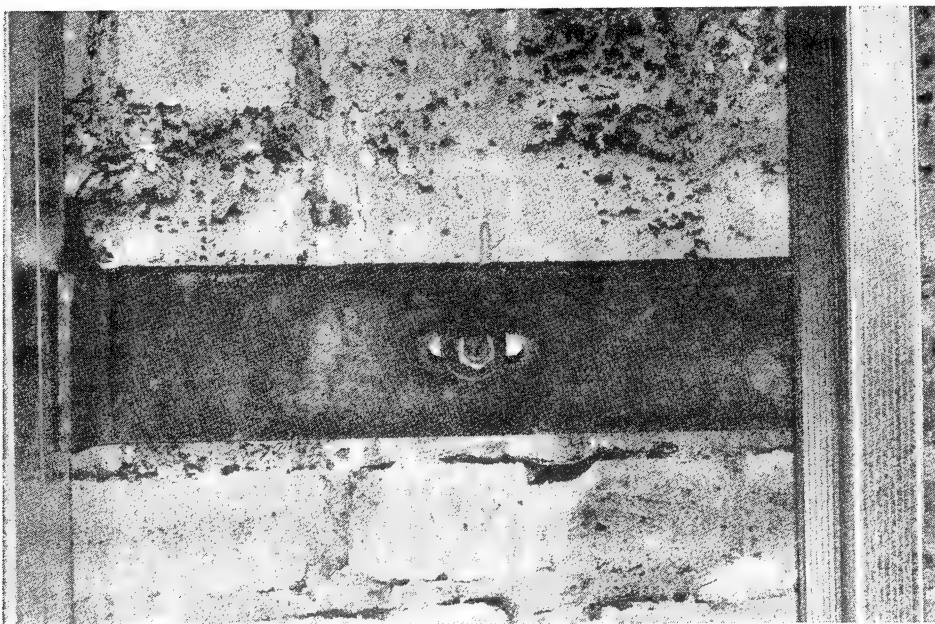
Figure 49. Detail of basketing anchor

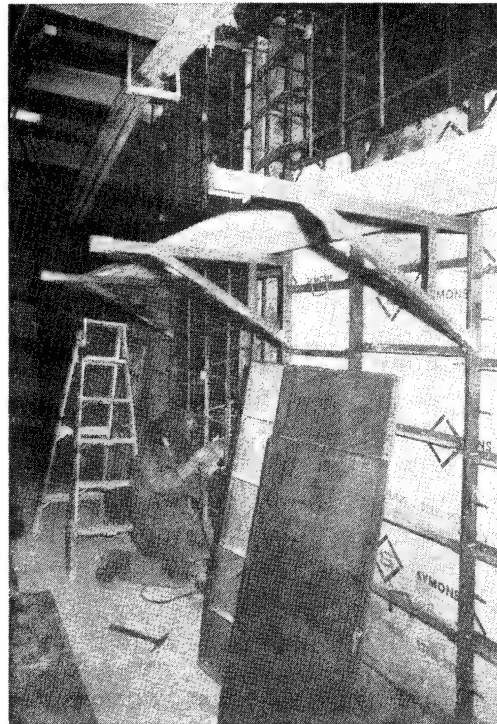
Figure 50. Forming for interior shear walls

Reinforcement of the exterior brick walls was important to the performance of the building in an earthquake, but it was only part of the story. To provide additional strength and ductility to resist major earthquakes, a new system of reinforced concrete shear walls was designed to be added around the stair and elevator shafts (Figure 50). This system, well distributed around the building in the upper stories, was supplemented by additional shear walls from the second floor down to the foundations.

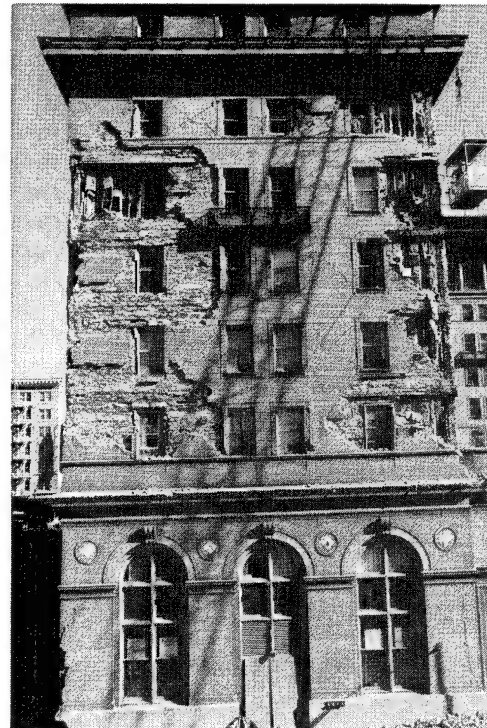
The most evident and significant damage sustained by the hotel was the cracking of the exterior brick walls. Although they are not load-bearing walls, the brick walls are the stiffest elements in the building and resisted the main thrust of the earthquake force. The walls are infill brick supported on the structural steel frame, and therefore the damage did not affect the vertical load-carrying capacity of the building. The damage to the brick was manifested as diagonal (X) cracks in the wall piers with virtually no cracking in the horizontal spandrels. Reference to Figure 51 shows this X cracking between bays of windows.

The most severe brick damage took place on the Thirteenth Street end of the Harrison Street wing of the building. There were cracks over 1/2 in. wide, with complex fracturing through the entire thickness of this wall. There were also areas where the face brick had fallen and other areas where it was loose.

Figure 51. Damage to southwest facade after removal of loose brick

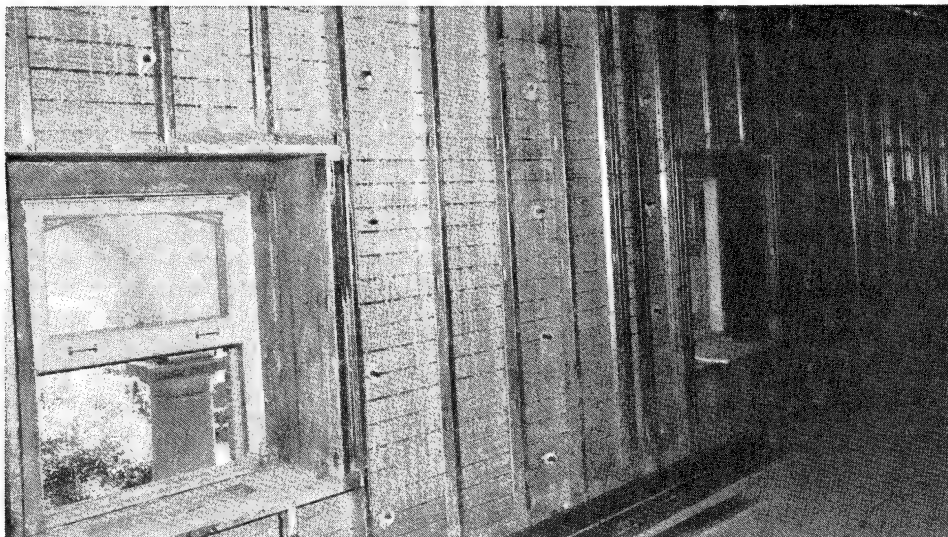
Figure 53. Strengthening of typical upper floor walls

In the first-story historic spaces, the strengthening walls are being located behind the existing historically sensitive wall surfaces to keep the architecture of the space clean (Figure 52). In the upper stories, Figure 53, the additional wall thickness will encroach into the living spaces and the units will be remodeled. Because of the tight spaces in which to work in pouring the new concrete shear walls against the existing brick and the limited amount of work space, the contractor devised an ingenious forming system. Stay-in-place formwork was used and held in place by metal studs that were in turn supported by steel dowels which were carefully placed and epoxied into the facade brick. The studs not only supported the forms but became the method of anchoring the brick to the new concrete walls. The studs were stiffened by wood blocking at each stud and laterally supported by walers. This method allowed for observation of the pour through the formwork and greatly simplified and accelerated the process. The metal studs that remained in place were used as furring for the interior finishes so there were no forms to remove, only the wood blocking and walers.
